Test Report

Our Ref: GBW Number 137009 Issue 1 Date 22/05/2015 Page 1 of 4

Tested For:- KEE SAFETY LOGISTICS LTD
Unit A2, Cradley Business Park
Overend Road
Cradley Heath
West Midlands
B64 7DW

SALT SPRAY TESTING OF YELLOW POWDERCOAT TUBE SAMPLE

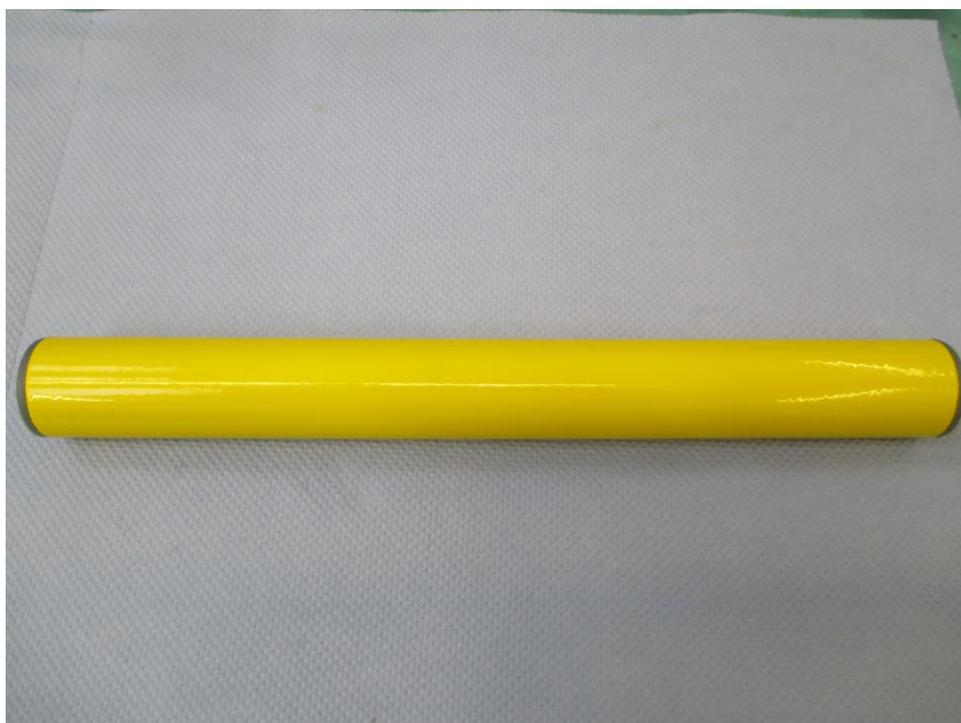
Pre – Test Assessment showed a number of seeds on the surface finish.

Fig 1: Photograph showing the condition of the 33.7 x 250mm Tube Sample prior to Salt Spray Test

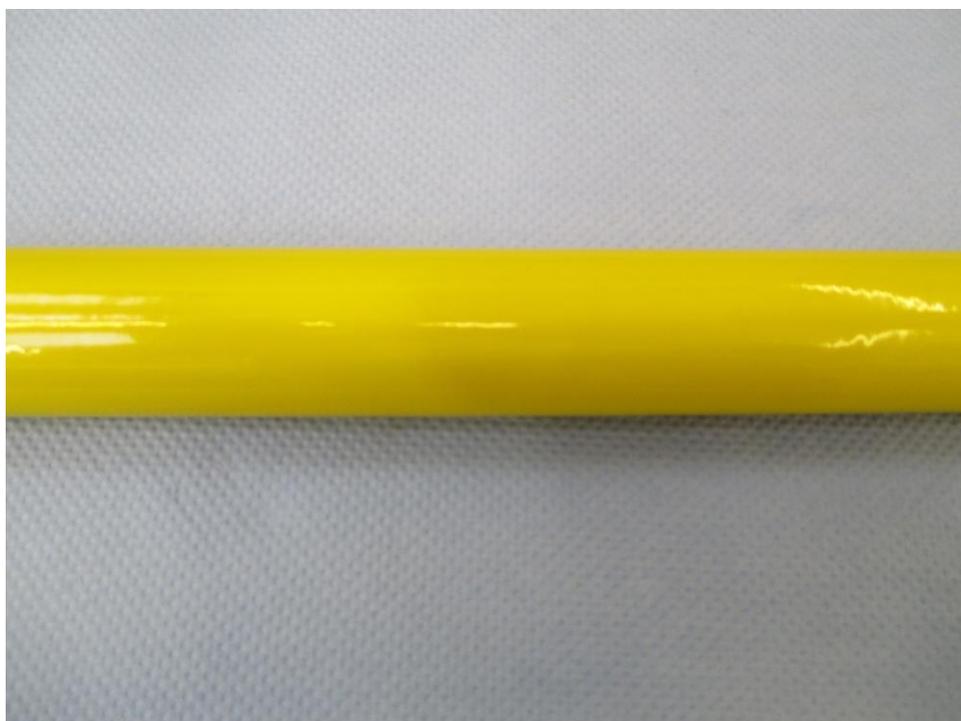
The photographs in fig 1 & 2 are showing the tube sample prior to test, the tube sample was then exposed to a neutral 5% Salt Spray for a test period of 216 hours, examinations after every 24 hours, revealed the following observations:-

Fig 2: Photograph showing the condition of the 33.7 x 250mm Tube Sample

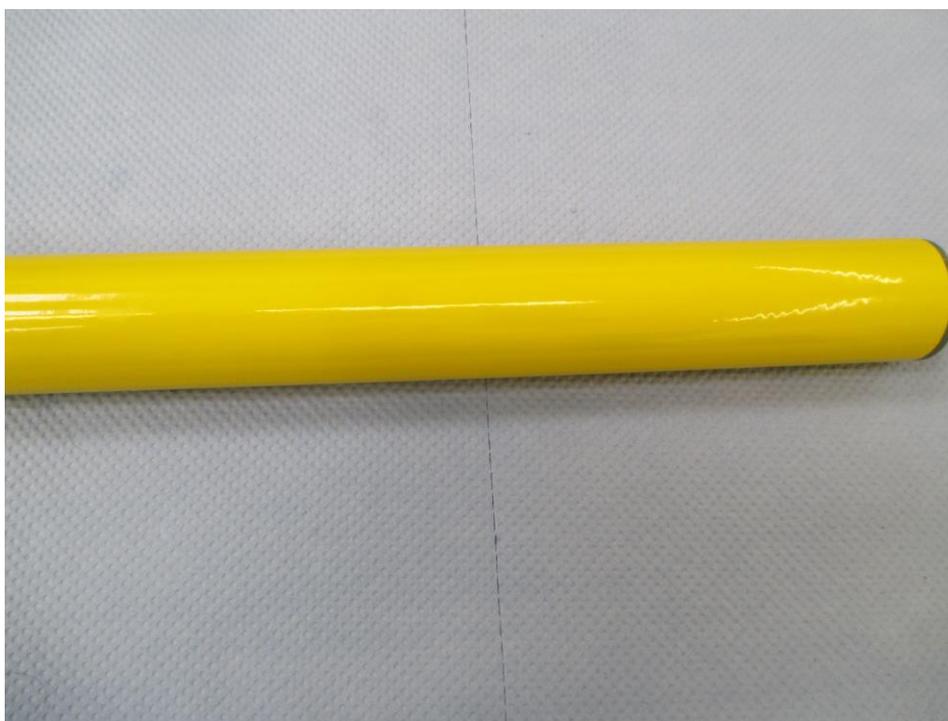
The tube sample showed no evidence of corrosion or deterioration of the finish (see photograph after 216 hours).

Fig 3: Photograph showing the condition of the 33.7 x 250mm Tube Sample after 216 hours Salt Spray Test

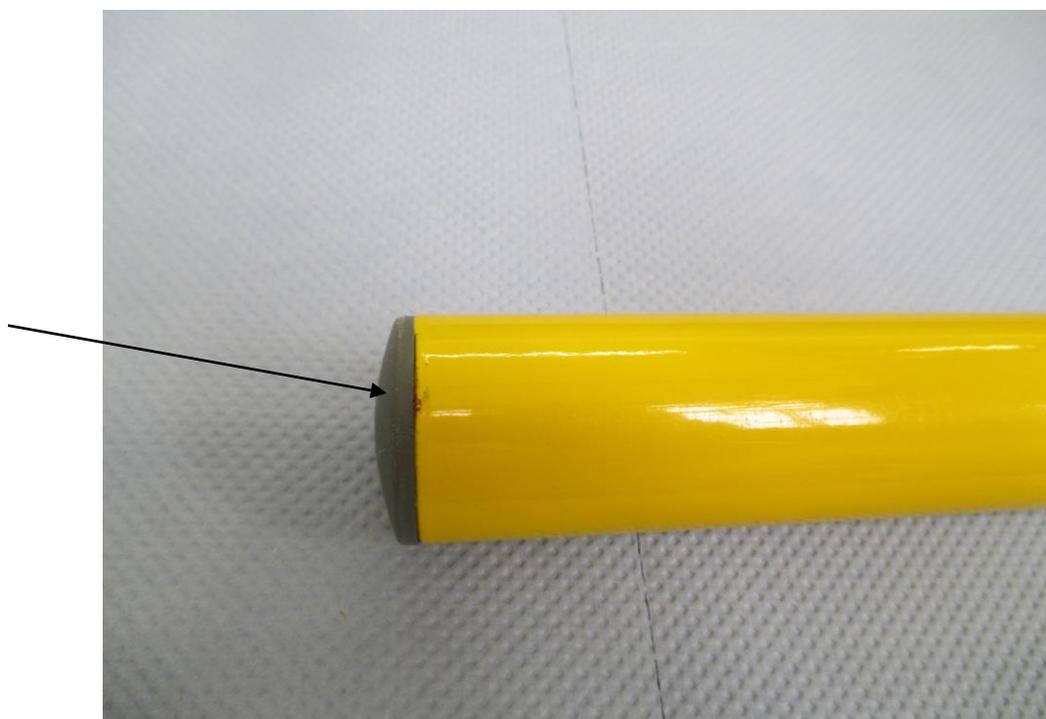
The tube sample showed evidence of one spot of red ferrous corrosion adjacent to the end cap, no other part of the tube sample showed evidence of corrosion or deterioration of the finish (see photographs after 216 hours).

The finish applied to the 33.7 x 250mm Tube Sample tested, **withstood** 216 hours Salt Spray Test requirement without significant breakdown.

Fig 4: Photograph showing the condition of the 33.7 x 250mm Tube Sample after 216 hours Salt Spray Test (corrosion spot)
